Troubleshooting the MPH-24FP Series Pedestal Hydrant

MAPA Products
MPH-24FP:24/9 Pedestal Hydrant

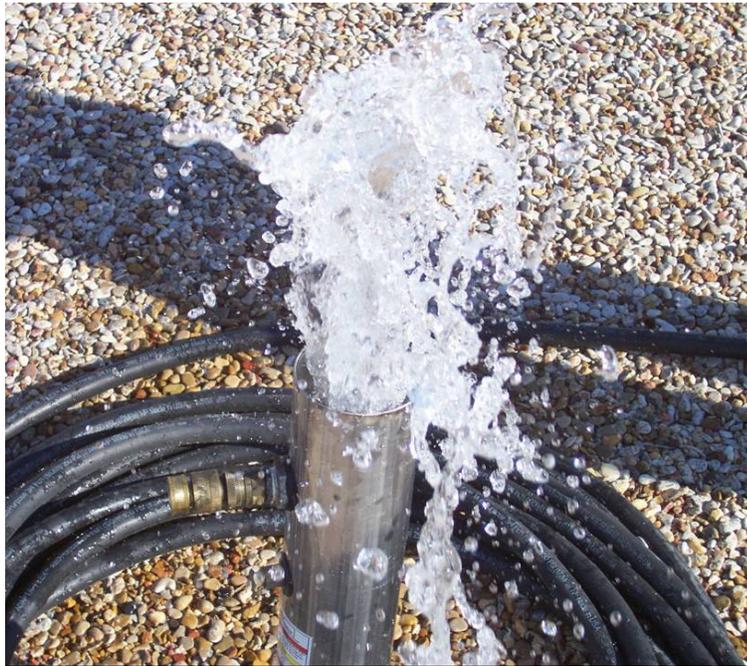
Please make sure that the water supply is turned OFF prior to making any repairs. The picture below indicates what happens when the water supply is left on.

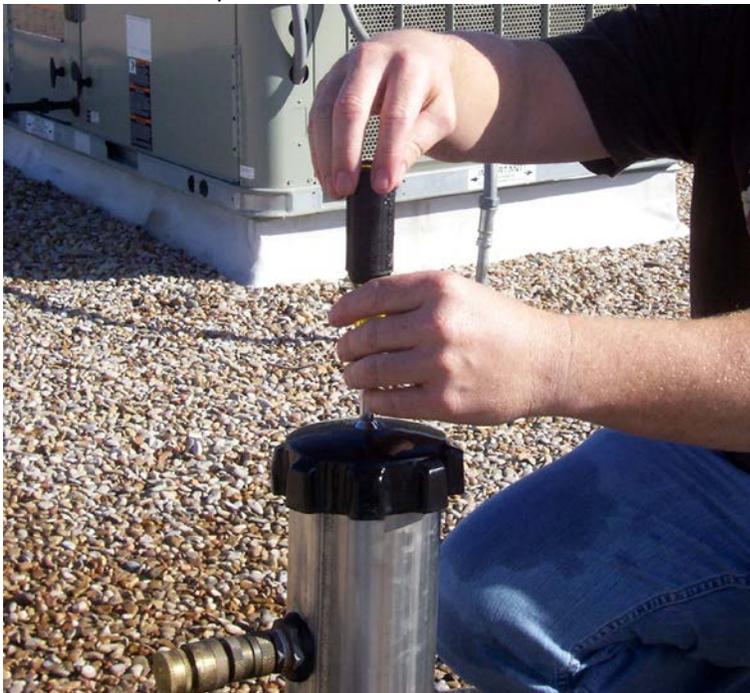
Dome Handle will not turn:

1: Remove Plastic Cap at the top of the Dome Handle.

2. Loosen and remove the 1/4" lock nut and washer inside the cavity.

Remove any foreign material and replace dome handle. In replacing the black nylon cap, use silicone adhesive equal to E-6000 to ensure that rain water does not enter the shroud.

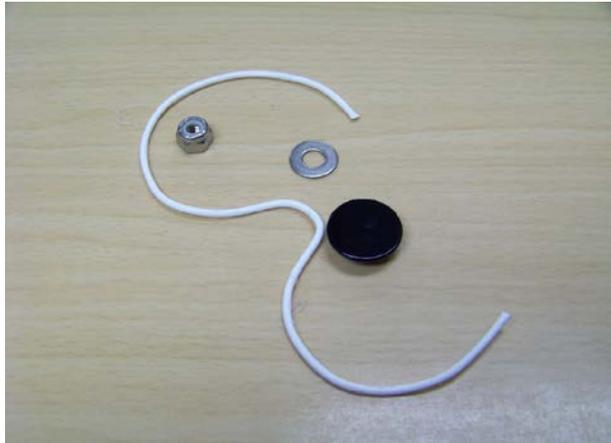
Water leaking from Packing Nut – Inside Shroud – You will need to determine when the hydrant was purchased and installed prior to Contacting the Factory for repair kit

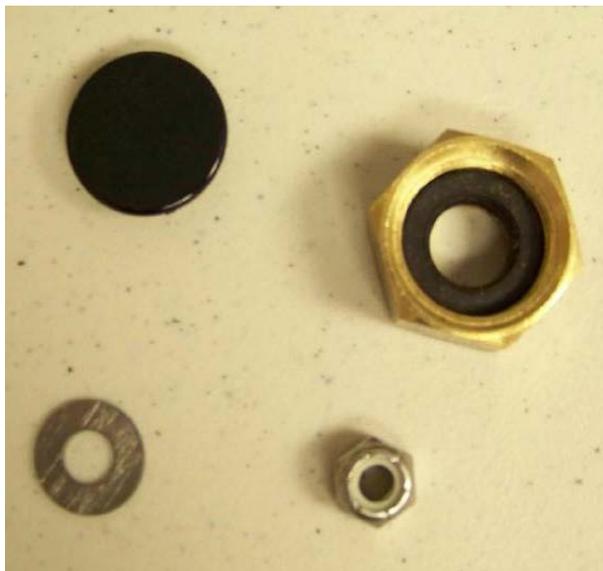
If hydrant was purchased prior 2007:

Replacement Parts for Dome Handle:

- Black Nylon Cap
- SS ¼" Flat Washer
- SS ¼" Lock Nut
- Packing string

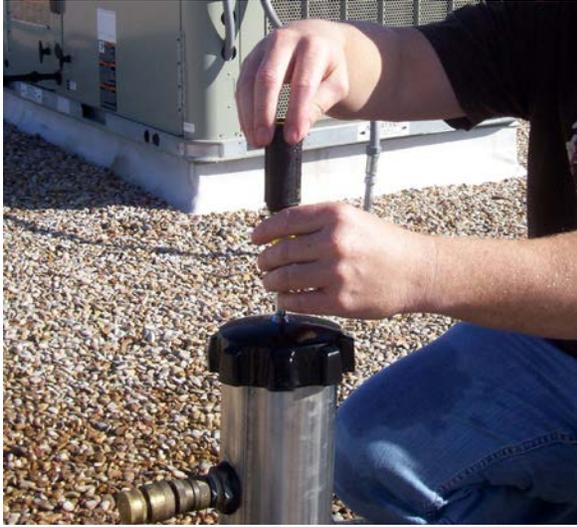
1: Remove Plastic Cap at the top of the Dome Handle.

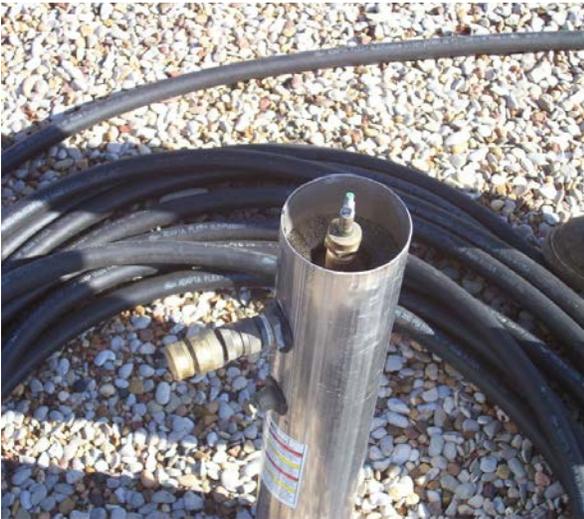
2. Loosen and remove the 1/4" lock nut and washer inside the cavity.

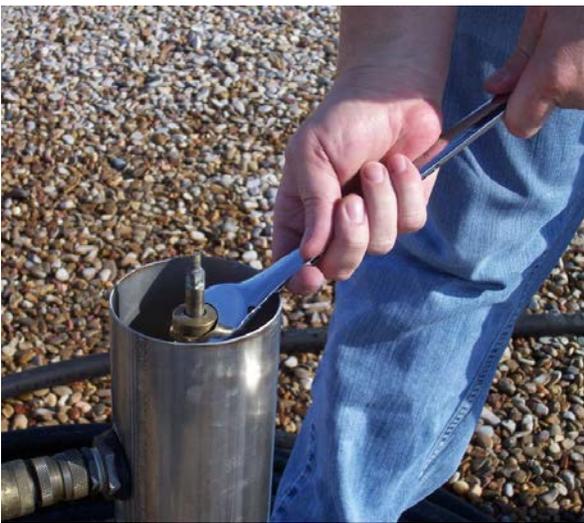
3. Remove the packing nut using a basin or other appropriate wrench.

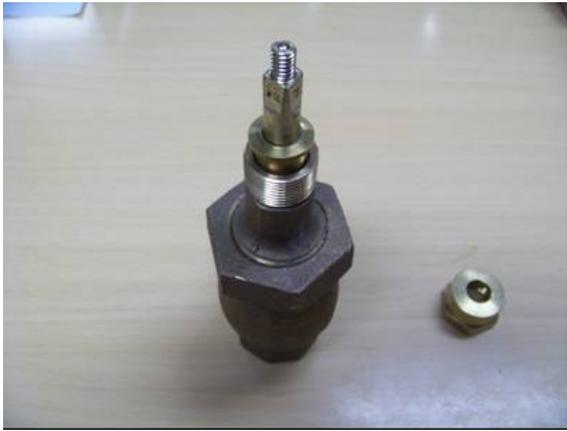
Step 4: Tap out the brass bushing.

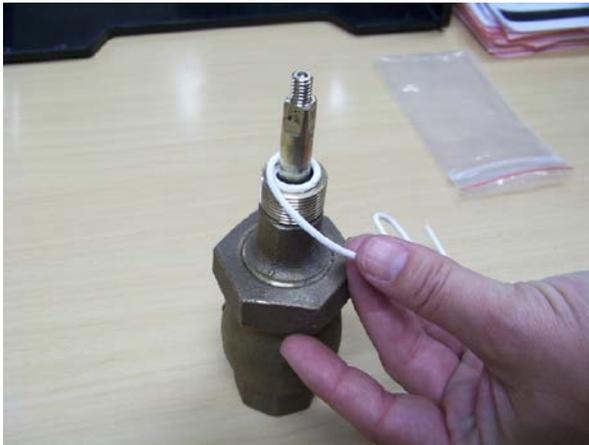
5. Wrap packing string around valve stem 2-3 times. You will have additional string remaining.

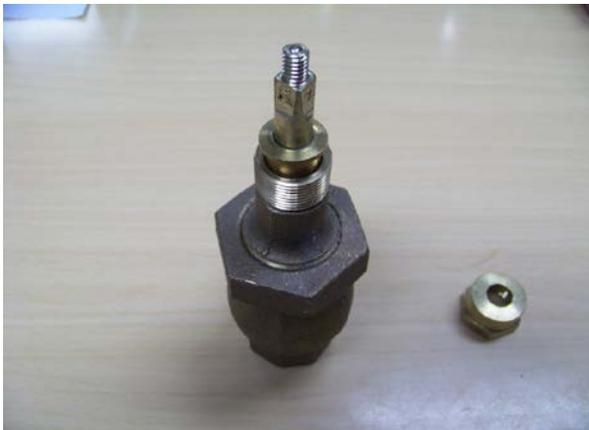
6. Replace bushing and packing nut. Tighten packing nut hand tight with an addition $\frac{1}{2}$ turn.

Step 7: Replace dome handle using replacement parts supplied in your repair kit. First place the SS Flat Washer, then the lock nut. Using a silicone adhesive equal to E-6100 to place the black cap in place to ensure that rain water does not enter shroud.

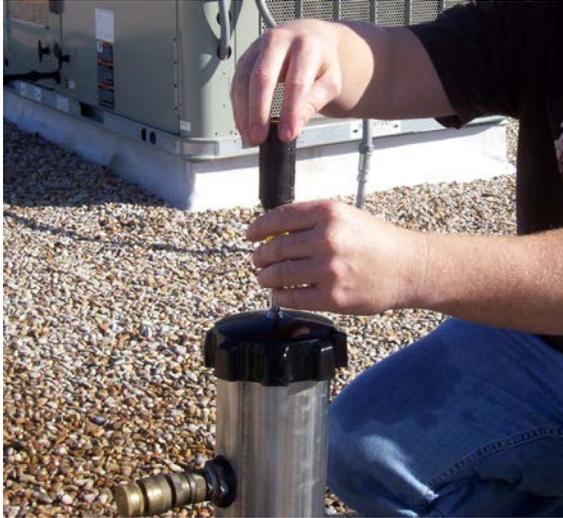
- 1: Remove Plastic Cap at the top of the Dome Handle.
2. Loosen and remove the 1/4" lock nut and washer inside the cavity.

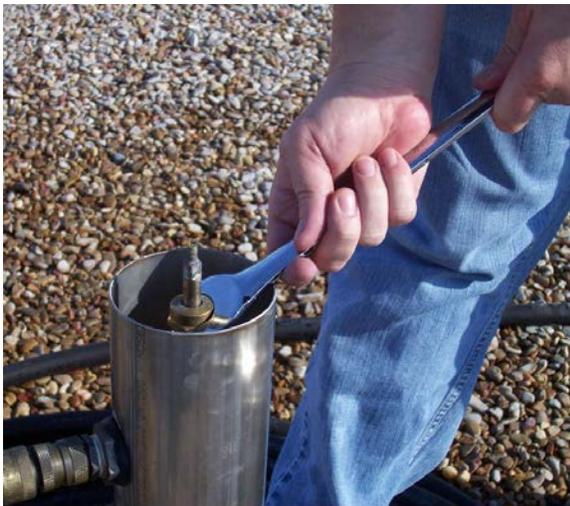
4. Remove the packing nut using a basin or other appropriate wrench.

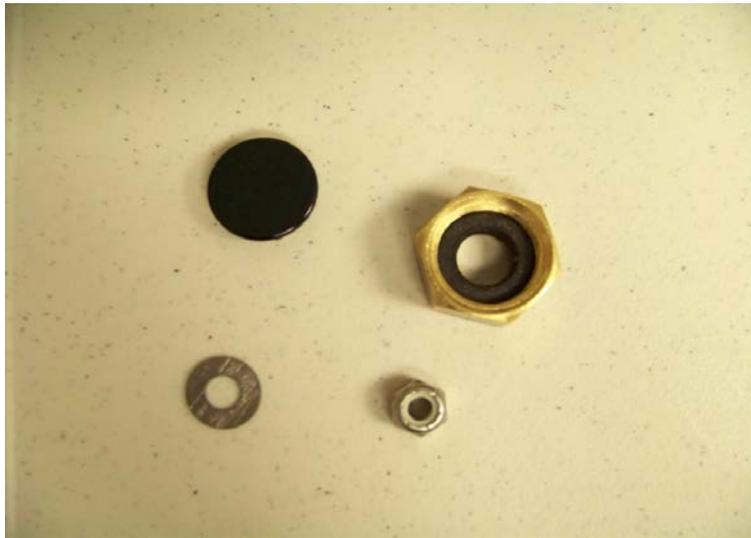
5. Replace packing nut with the one supplied in your repair kit.

6. Replace dome handle using replacement parts supplied in your repair kit. First place the SS Flat Washer, then the lock nut. Using a silicone adhesive equal to E-6100 to place the black cap in place to ensure that rain water does not enter shroud.

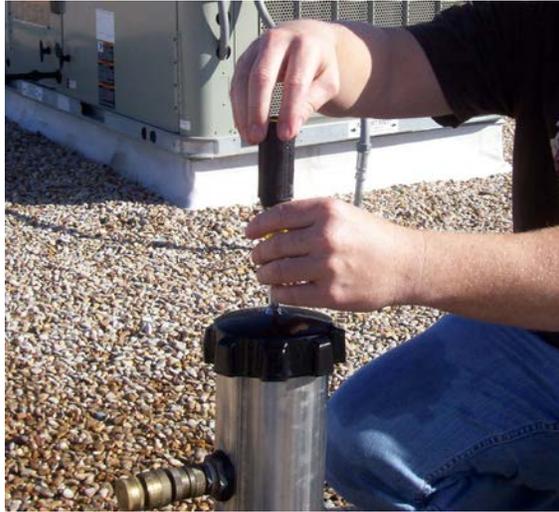
Water continues to run when Dome Handle is turned to the OFF Position. This indicates that the Stopper of the Valve Stem is not seating properly within the Nozzle.

- 1: Remove Plastic Cap at the top of the Dome Handle.
2. Loosen and remove the ¼" lock nut and washer inside the cavity.

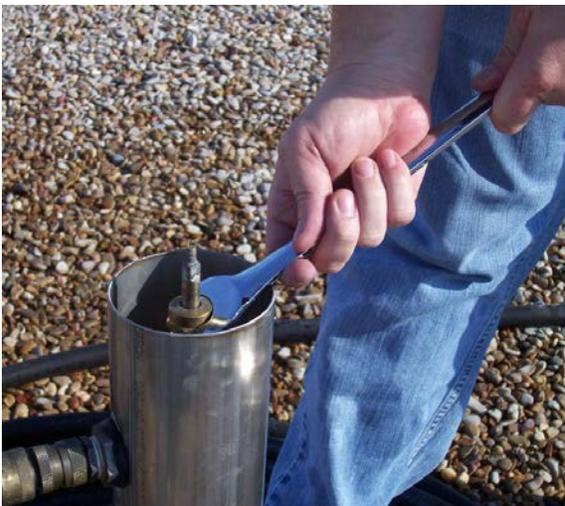
4. Remove the packing nut using a basin or other appropriate wrench.

5. The valve stem and shaft will lift out of the hydrant.

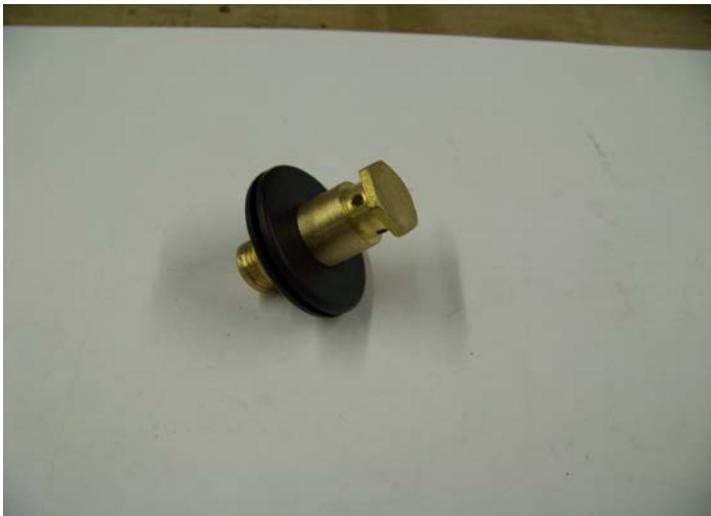
Float Valve Assembly - Water leaking through the Brass Float Valve Assembly located beneath the quick hose connect. – Outside of Shroud

1. Remove assembly from hydrant using a wrench

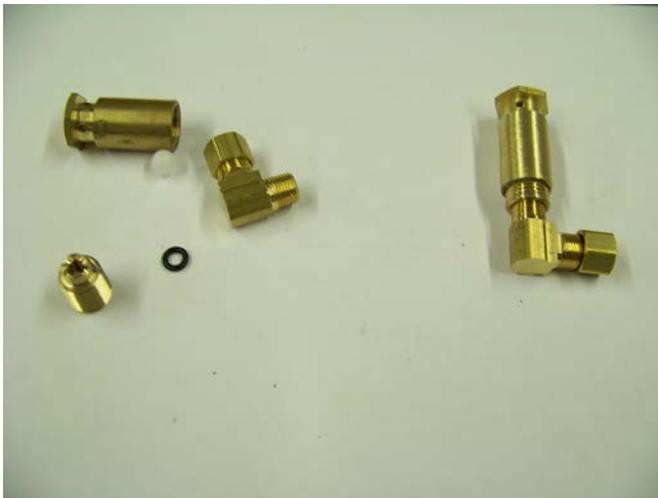
2. Blow air into the holes of the assembly to dislodge any debris that has accumulated around the nylon ball. This will cause the ball not to seat properly thus allowing water through.

3. Replace the float valve assembly onto the shroud of the hydrant.
